Deer and Pokegama Lakes Stream Phosphorus Reduction: Stream Geomorphology Report

April 2017

HR Green

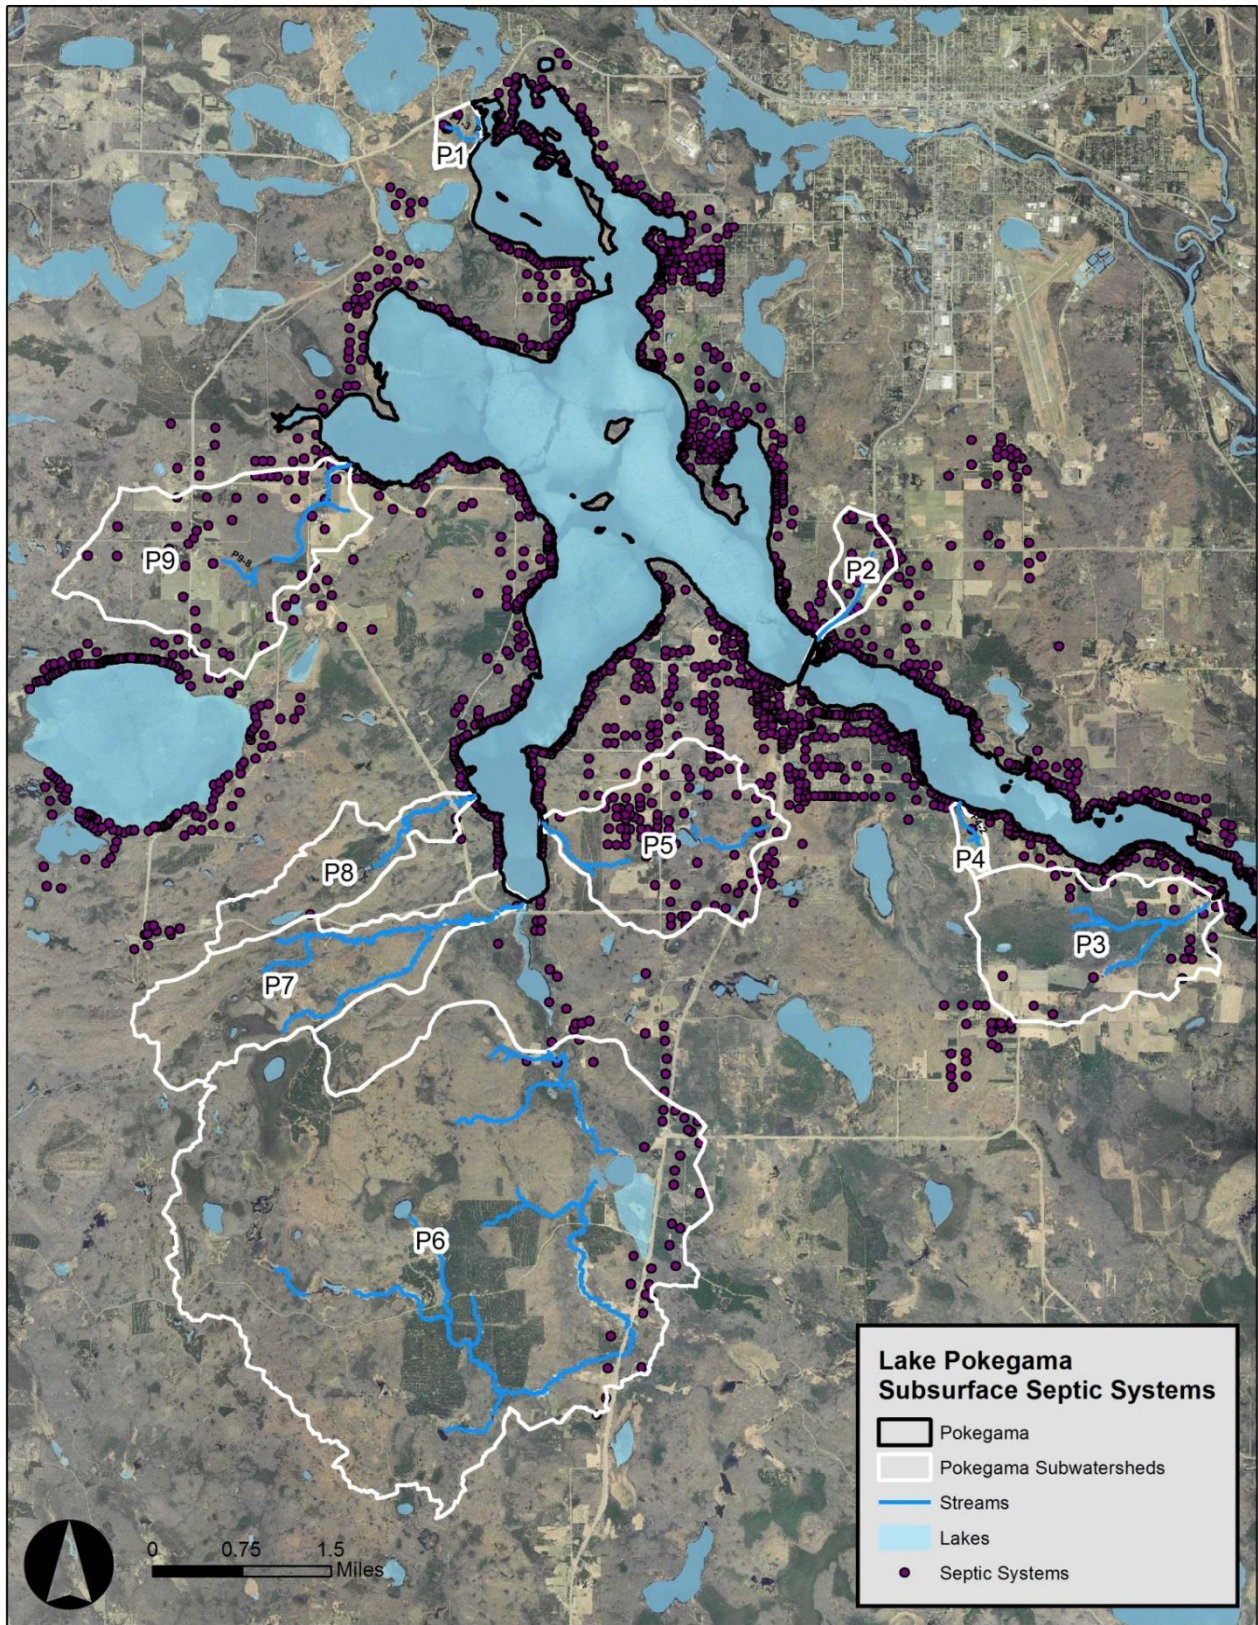
Figure 5. Subsurface sanitary drain fields in the Lake Pokegama watershed.

Subsurface sewage treatment systems (SSTS) were mapped for the Pokegama watershed to investigate relative proximity to stream channels (Figure 5). No attempt was made to validate the County's spatial data accuracy for the exact position within the landscape. Subwatershed P3 has two SSTS close to the stream channel, though the channel itself appears stable and no immediate risk of meander migration into the SSTS is prevalent under the climatic conditions experienced to-date. Similarly, P5 has several (6 to 10) SSTS that may be close to the upper portion of the subwatershed's area and the channel is stable and does not drain to Lake Pokegama (this subwatershed is hydrologically non-contributing). Subwatershed P6 has two SSTS at the midpoint of its drainage area and 2 proximal to a tributary near its outlet to the wetlands along the south shore of the Lake. It is unlikely that the SSTS in the midpoint of the subwatershed (along Highway 169) are at risk of being encroached on. The tributary nearest the subwatershed's outlet were unable to be visited due to access limitations (private property). Subwatershed P9 has five SSTS near its channel. The upper channel SSTS is located at the channels origination and is at very low risk of channel migration. The lower SSTS are located along a channel undergoing aggradation and should be considered moderately at risk depending upon their actual distance from the channel. The channel in the lower P9 subwatershed does not appear to be undergoing significant bank migration but should be monitored through time.

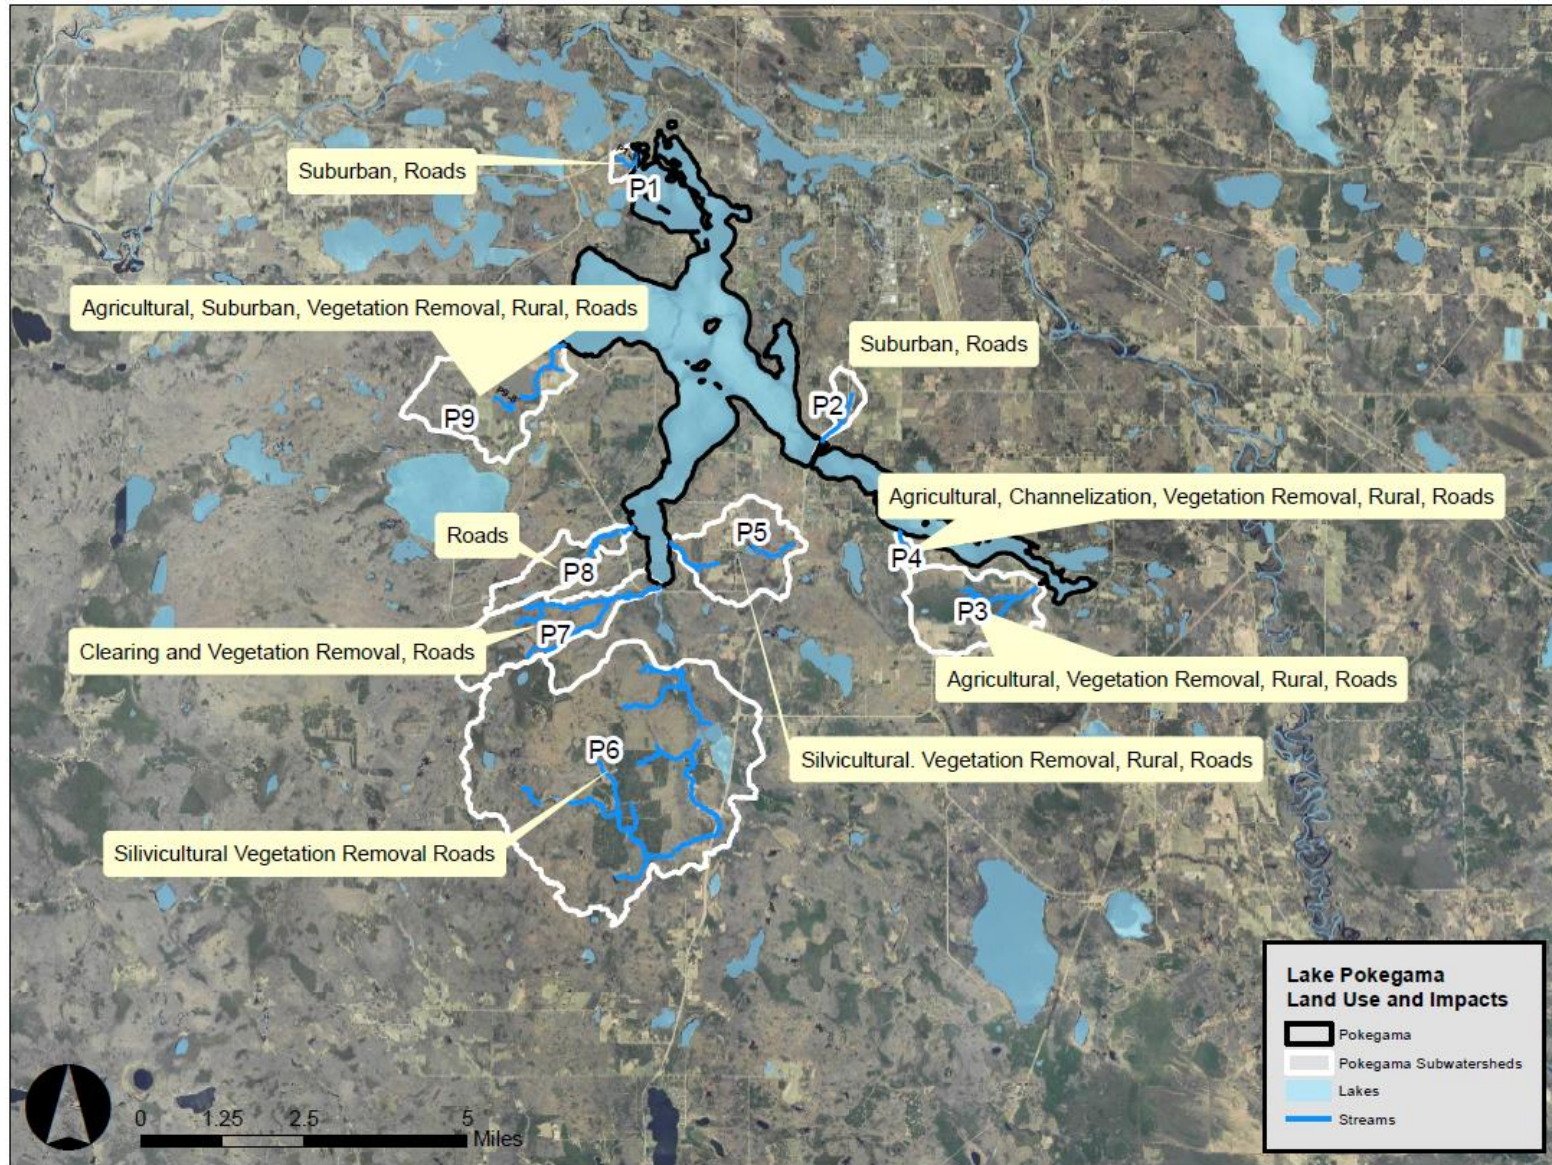
Figure 7. Land use and impacts within the Lake Pokegama watershed.

Land use, erosional processes and streamflow changes were assessed to identify potential stream impacts in this study (Figure 7; Figure 8). Stable stream channels were strongly correlated to natural, stable upstream drainage areas. In areas with minimal landscape alteration, streams remained stable and resilient to previous extreme climatic events. The extreme rainfall events of 2012-2013 caused a shift in stream alignment and cross sectional geometry of the highly susceptible Type A channel within P8, though it regained stability within 3 years to the state it is in today. This channel is an example of the resilience of streams to episodic climate events within natural watersheds and should serve as a reference site for similar stream-valley types in the region that are currently or have in the past experienced land cover or hydrologic modifications. Hydrologic modifications to the mid-to-upper watershed in P9, however, illustrate how reductions in flow cause sediment build up, bank failure and channel evolution. This modification is driven by an extensive beaver dam that has led to a radical shift

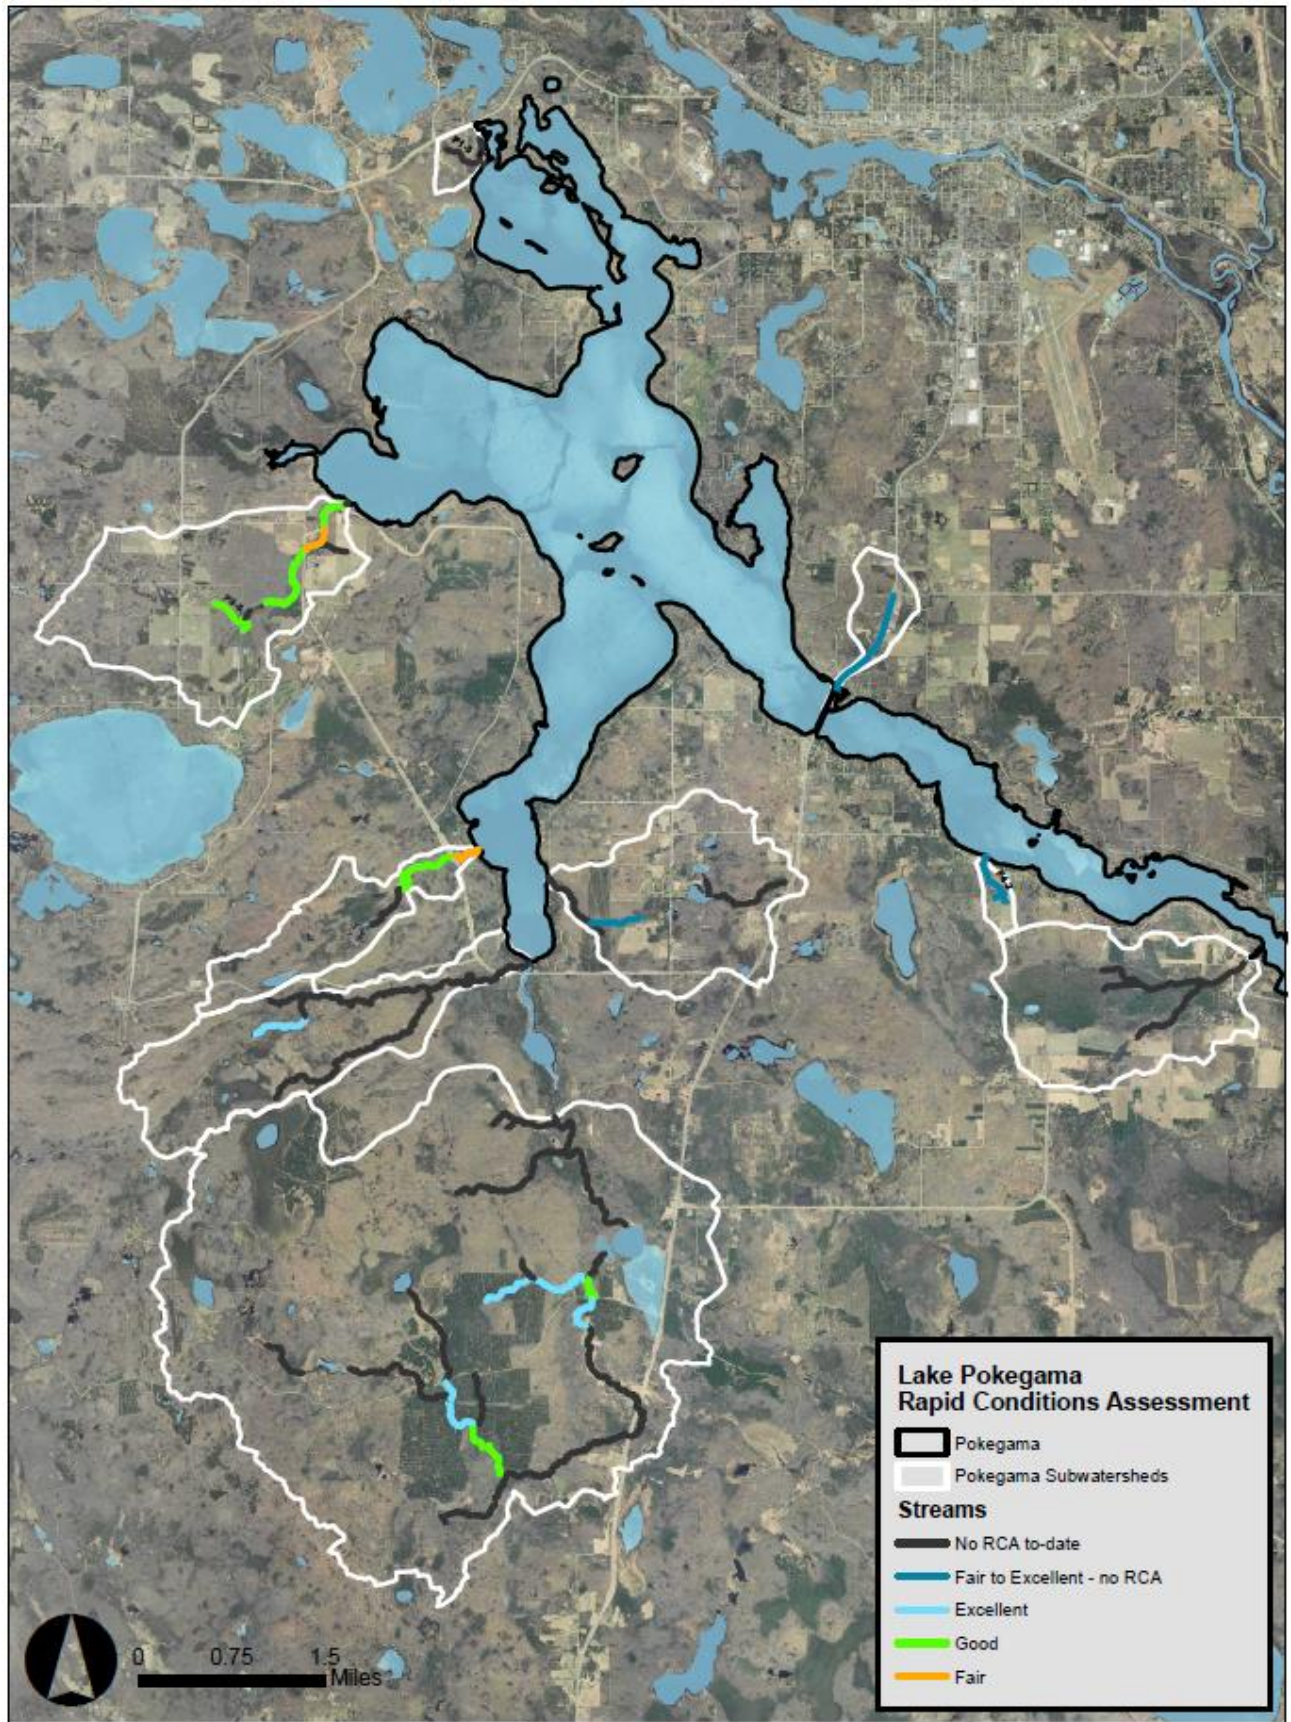
Figure 9. Rapid condition assessment results for reaches within the Lake Pokegama watershed.

A rapid condition assessment was made for reaches identified as most susceptible to impairments as the result of the desktop analysis (Table 7; Figure 9). This analysis estimated the current ecological health of the reaches using several metrics as a means of assisting in determination of stability, nutrient export and as ability to support for macroinvertebrates and fish. Possible scores were poor, fair, good or excellent. Results ranged from fair to excellent with six reaches being fair, seven being good, and five being excellent. One reach was a roadway drainage swale and, in as such, was not scored for ecological health. Unvisited reaches are expected to score predominantly good to excellent. This condition assessment should be considered a preliminary assessment of impairments similar to, but not as extensive as, the Minnesota Pollution Control Agency’s (MPCA) monitoring efforts for determination of impaired waters during the Stressor Identification phase of Watershed Restoration and Protection (WRAPS) planning.

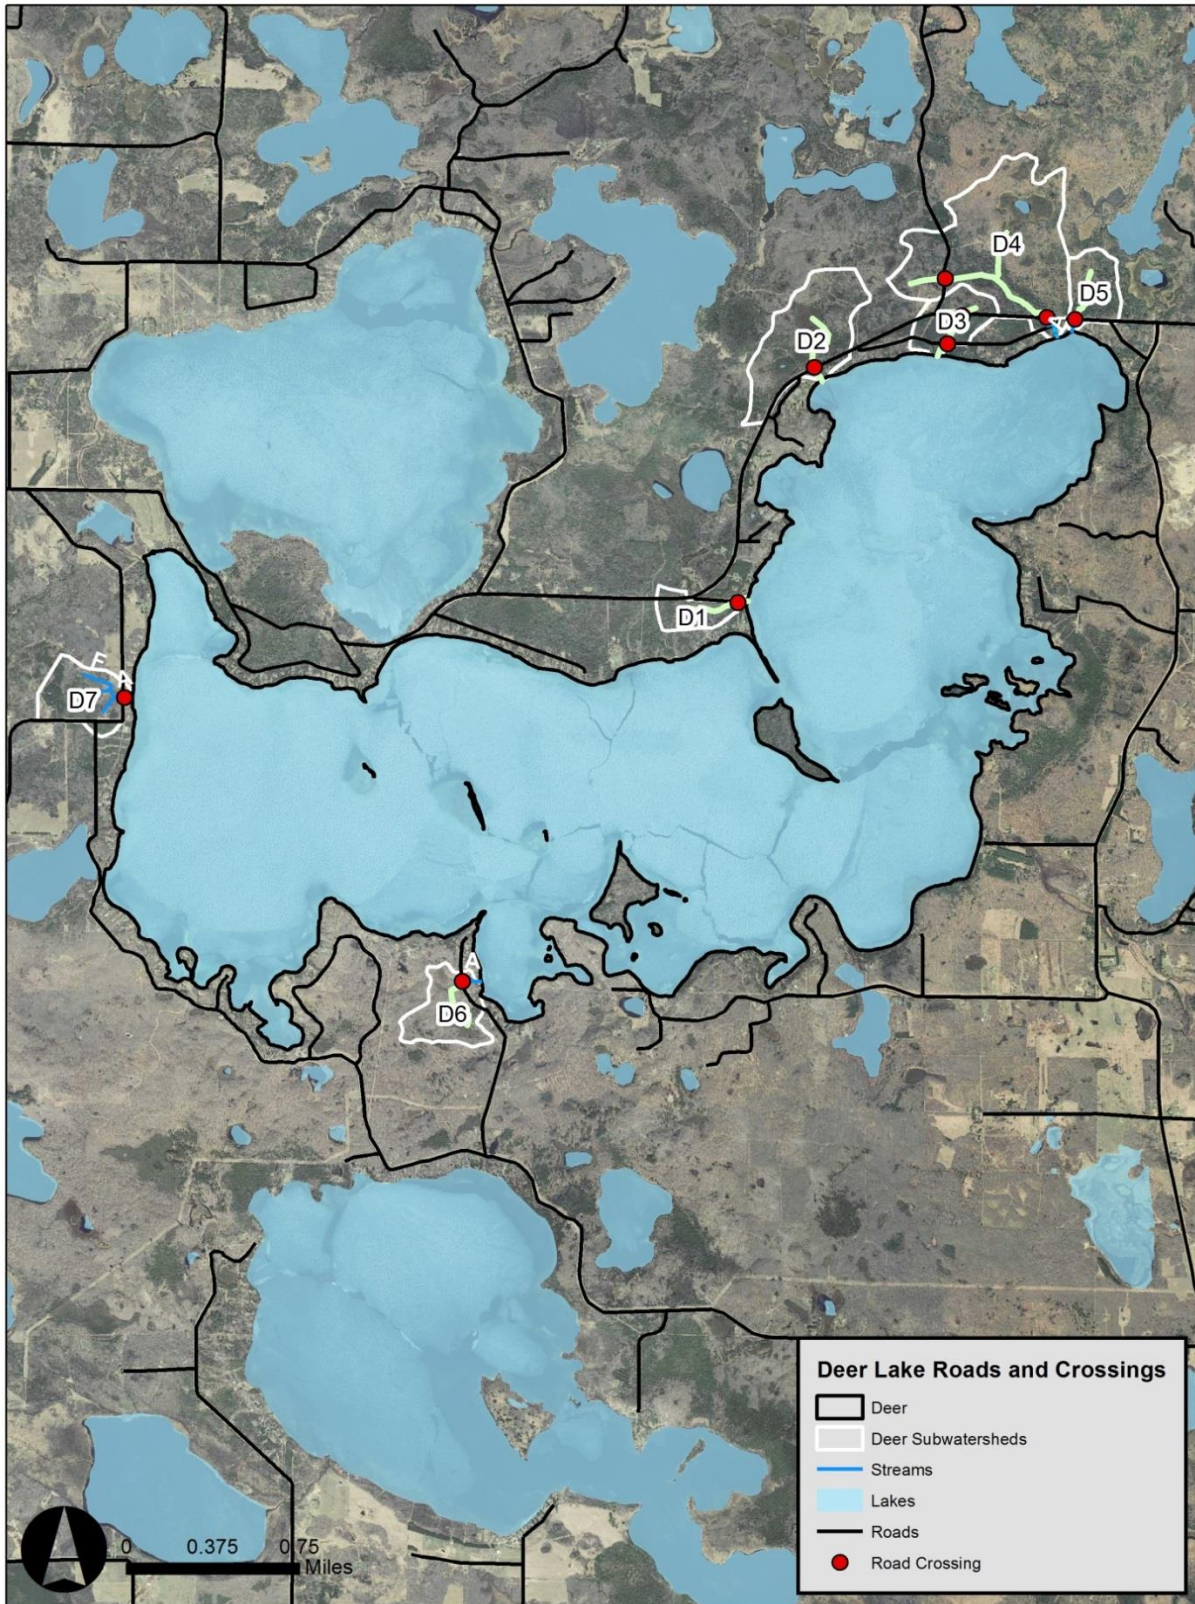
Figure 13. Roads and stream crossings in the Deer Lake watershed.

In stark contrast to Pokegama's watershed, Deer Lake's watershed has only eight road crossings (Figure 13). Seven of these were observed in the field, each apparently with capacity to adequately flows without causing excessive erosion points. Total road density within the subwatersheds of Deer Lake are also far smaller than Pokegama suggesting less influence of road-surface transport of sediments than in Pokegama.

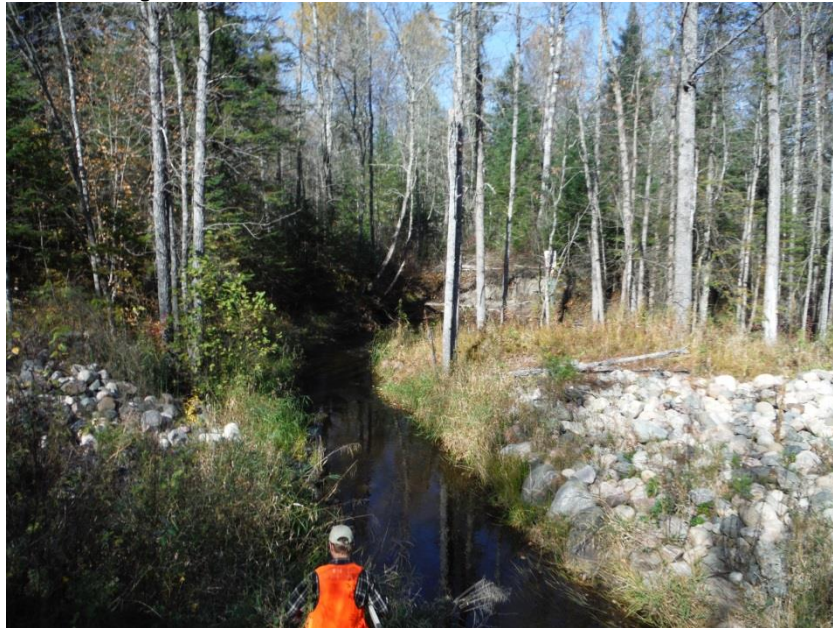
Figure 19. Pokegama reach P6.5 bank failure.

Also within P6 is an actively eroding reach south of the Smith Lake Road bridge; the scene of a bridge blow-out in the 2012-2013 storms. An extensive lateral and mid-channel gravel bar has formed downstream of the bridge, pushing the flows to the outer banks. This has increased toe scouring and subsequent sloughing of banks resulting in tall vertical banks and export of sediments downstream that may be putting additional banks at risk of accelerated erosion and habitat loss. It is recommended that simple toe-wood and cedar tree revetments be installed on the first, possibly the second bend downstream of the bridge. The gravel bar and sands deposited in this reach can be excavated and placed in these bank treatments to help reform a channel cross section using stable reaches reference dimensional ratios in the area.

Looking downstream from the bridge on Smith Creek Road.

Large bank cut (~8-ft) downstream of new bridge off Smith Creek Trail access off Highway 169. Brook trout (~8-inch) and Caddisfly cases observed. A review of Google EarthPro revealed that the 2012 storms likely caused major damage in this section of P6-5 leading to a temporary bridge installation in 2013 and potential bank stabilization work. The current bridge appears to have been installed following that work.

5. It is recommended that Itasca SWCD consider installation of a toe-wood bioengineered bank treatment along Smith Creek, upstream from Smith Lake and immediately downstream of the new bridge built circa 2013 (P6.5). This listed Trout stream was the site of a bridge blow-out during excessively heavy storms in 2012-2013, further causing the downstream bank to destabilize. The bank is actively eroding, causing downstream deposition of sands and gravels, forming bars that push flows to outer banks and thereby, increasing the risk of accelerated or new bank erosion and sediment/nutrient export along downstream sections.

It is recommended that a combination of Cedar Tree revetments and toe-wood be installed on the first two bends of P6.5 (Figure 18; Figure 19; Figure 20; Figure 21) for a very tight set of meanders currently still actively eroding as the result of the 2012-2013 storms. Minor channel reformation is also recommended to balance sediment transport to maintain a stable channel form and gravel bottom. Approximately 350 linear feet (as measured from stream center line) of work will be required: approximately 175 feet of outside bank work related to cedar tree and toe-wood and the remaining outside and inside banks likely only needing minor re-grading and bioengineering (~625 feet in total). Bank treatments should focus on the use of cedar tree revetments (approximately 100 linear feet; Figure 22) with toe-wood installations limited to the apex of both bends. Habitat provision should be made by constructing either bank treatment with overhanging shelter, pool excavation at the two bends and placement of instream boulders.
