Deer and Pokegama Lakes Stream Phosphorus Reduction: Stream Geomorphology Report

April 2017

HR Green

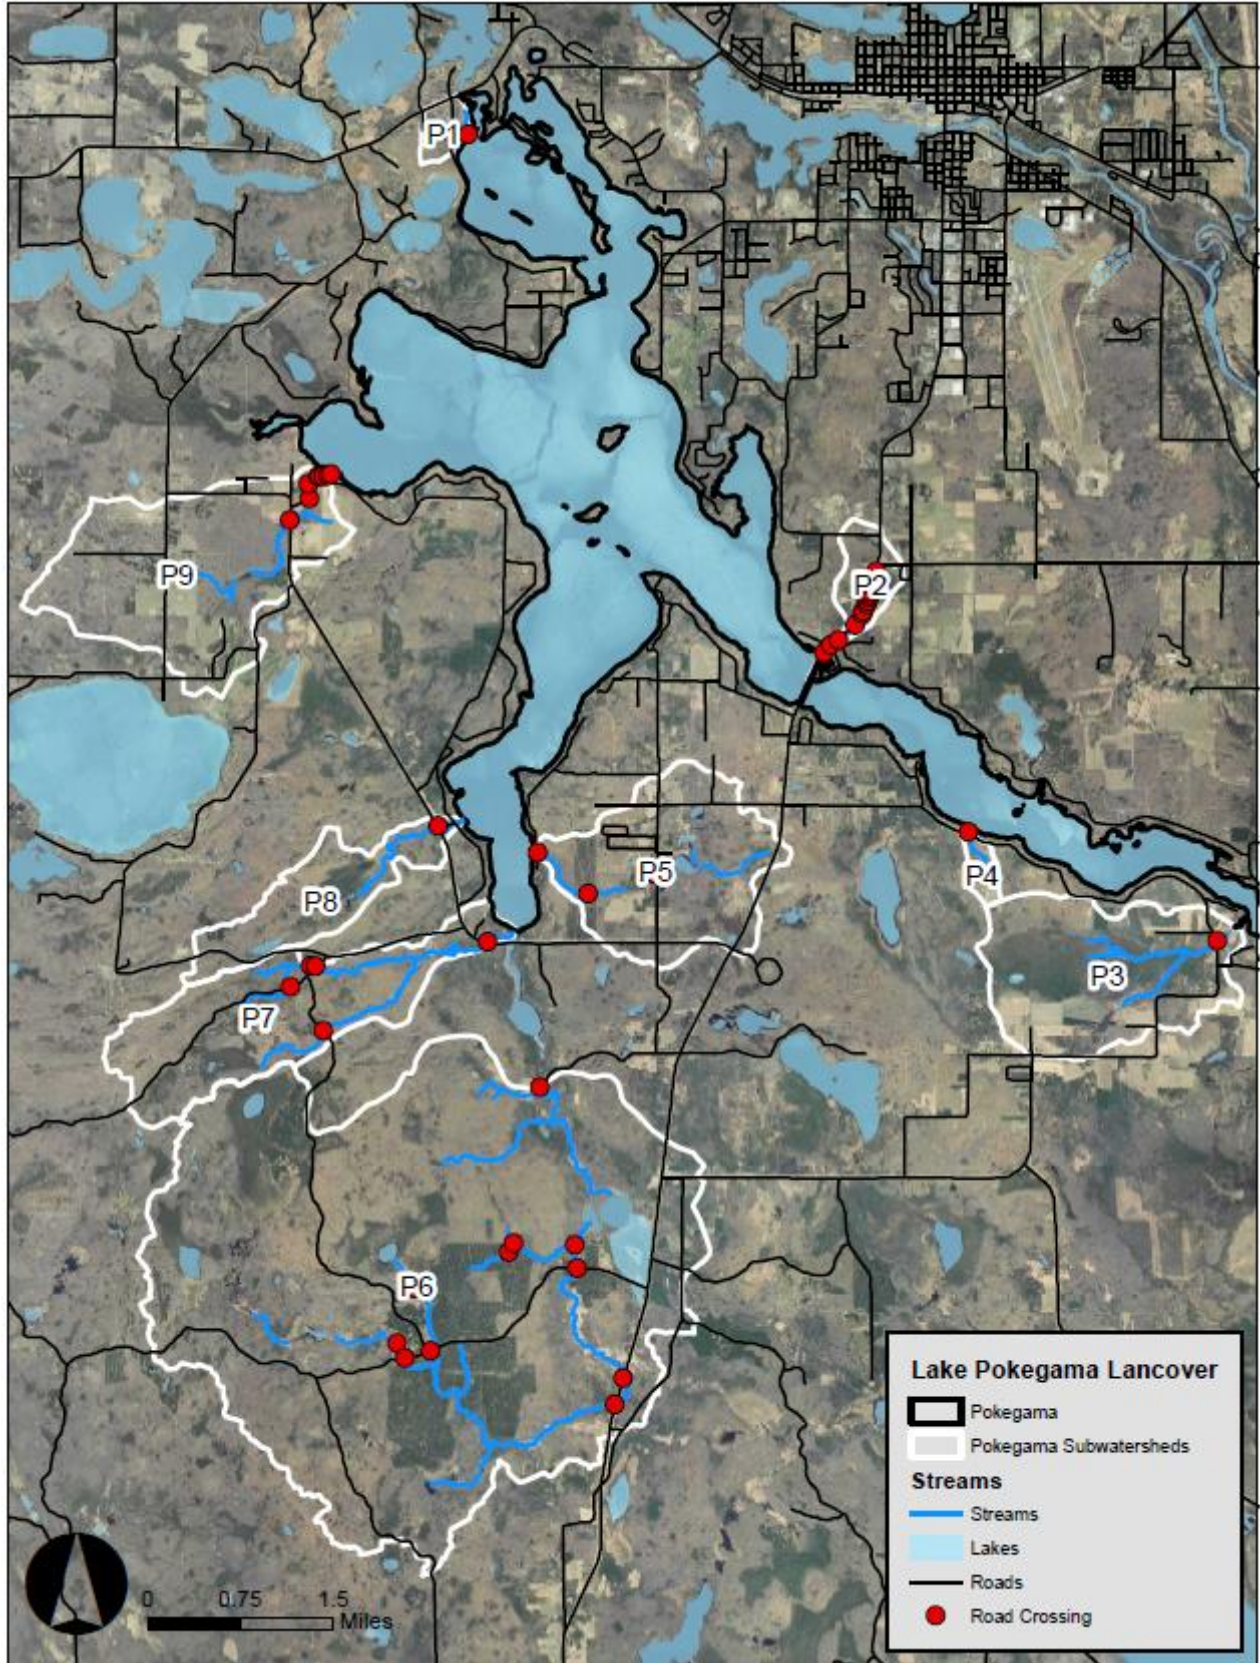
Figure 4. Roads and stream crossings in the Lake Pokegama watershed.

Roads and their stream crossings can have a direct impact on streams, their channels and sediment and nutrient transport. In the storms of 2012-2013, at least three road crossings were destroyed and subsequently repaired. Twenty-four road crossings were visited across each subwatershed within the Pokegama Lake watershed (Figure 4). Upstream and downstream indicators of culvert-induced influences were inspected including bank failure, bed aggradation (sedimentation), bed degradation (down cutting) and culvert end running (erosion around the culvert). No obvious influences on culverts were noted in the field. Considering this and the apparent resilience to the 2012-2013 storm flows, it is likely culverts and crossings within the watershed are capable of passing flows at a rate suitable for Pokegama's channels.

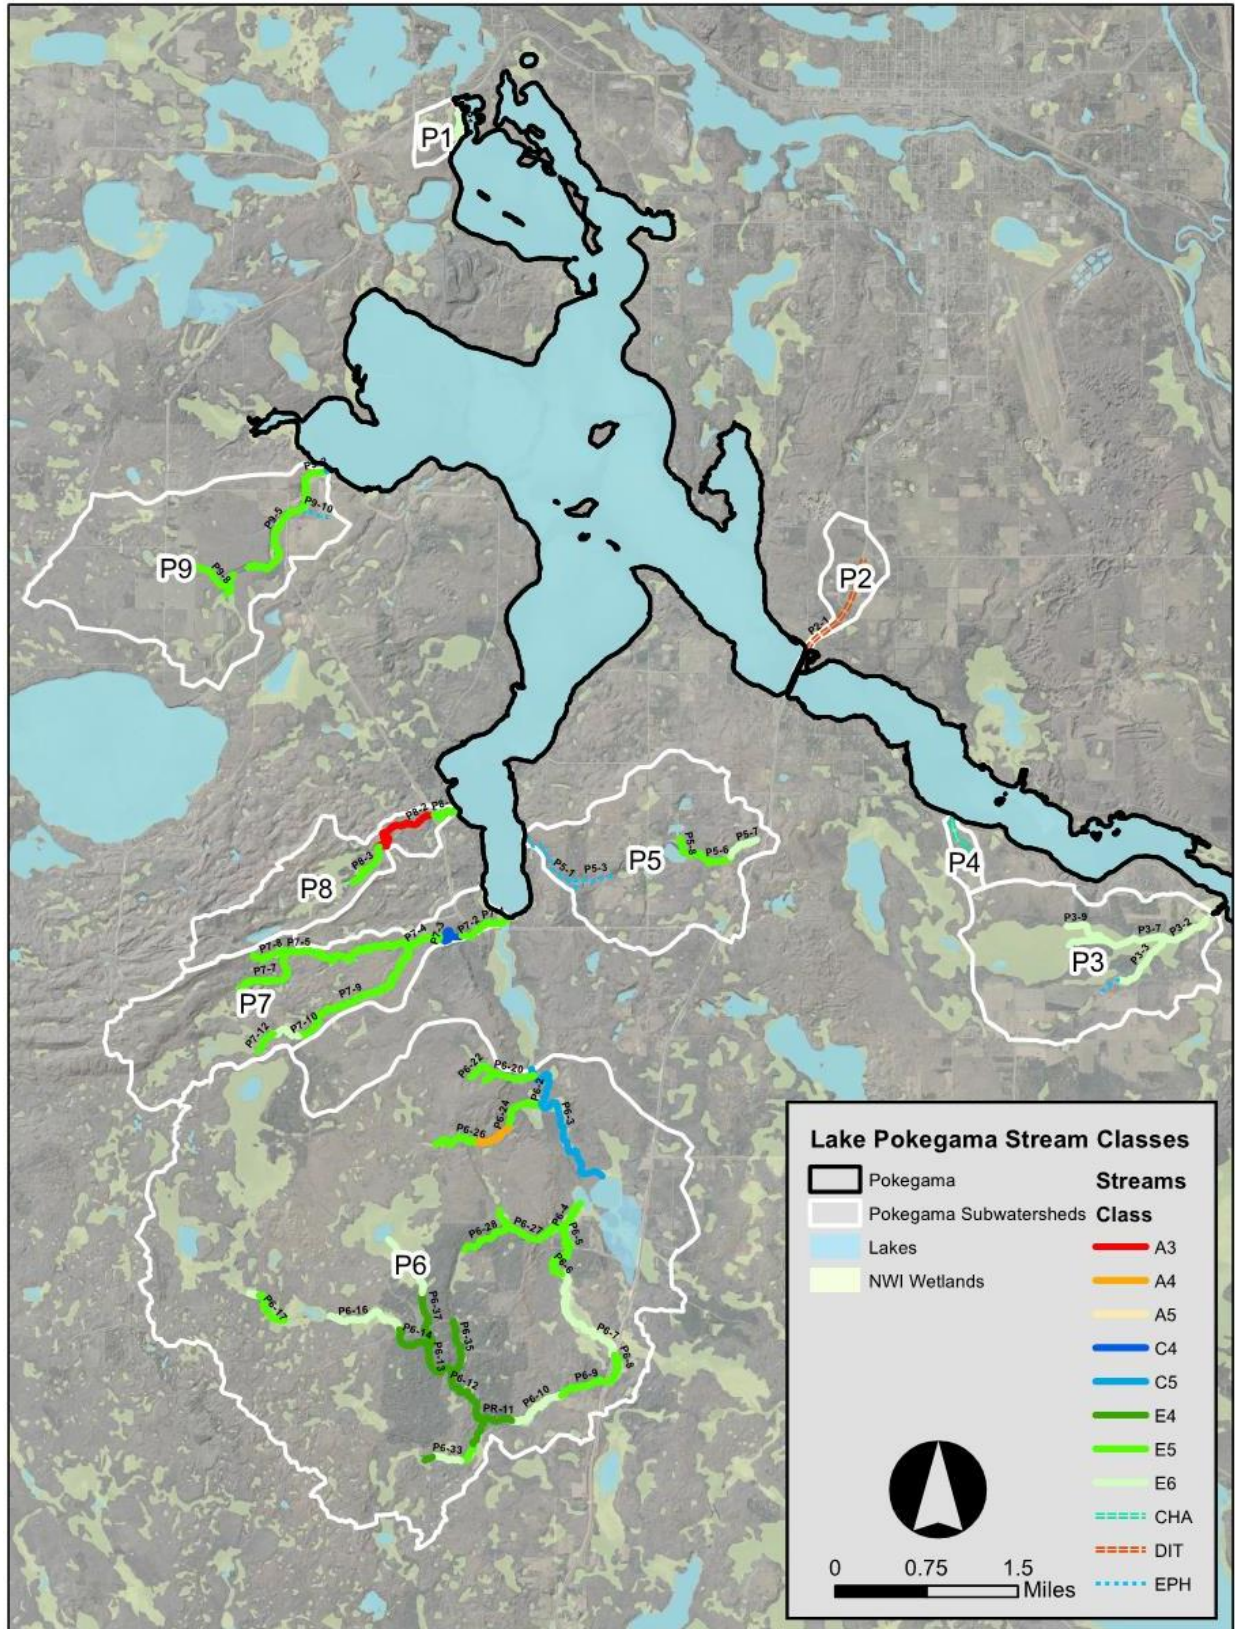
Figure 6. Rosgen stream classes of reaches within the Lake Pokegama watershed.

their position within channel evolution characterize their classes and evolutionary stage (Figure 6). Evolutionary stages help the assessment determine a channel's deviation from equilibrium and predict the subsequent stages to expect until equilibrium is regained. Very few disequilibrium stages were identified within this assessment. Some notable exceptions were identified, however. Subwatershed P6 provided evidence of channel evolution as induced from logging practices 15-30 years ago. In this subwatershed's headwaters (first and some second order reaches), floodplains and banks were harvested causing an influx of sediment and runoff. The headwater channels were likely similar in morphology to what was observed in un-logged areas (or areas logged greater than 20-30 years ago), but adjusted their alignment and cross sectional dimensions as the result. Sediment export to Smith Lake was likely very high during this period of time and the years preceding it. Sediments carrying nutrients have likely accumulated within the lake, where at least twice a year, anoxic conditions and lake turnover cause nutrient export to Lake Pokegama. (No evaluation of in-lake nutrient dynamics was made during this study.) This assessment suggests that the average stream recovery time related to a change in forestry practices in the Till Plain region of the watershed is 20-30 years. Currently, these streams, though not completely recovered back to their stable channel form, are nearly back to their stable dimensions. Fish habitat is still in recovery mode, as the channels are currently shallower and wider than what would be considered the stable channel form. These reaches' evolution to stable form, upstream of Smith Lake, could be accelerated via simple bank treatments to narrow the channel cross section and to provide bank cover for its Brook Trout populations. This narrowing would help scour sediments, exposing additional spawning beds (beds) as well.

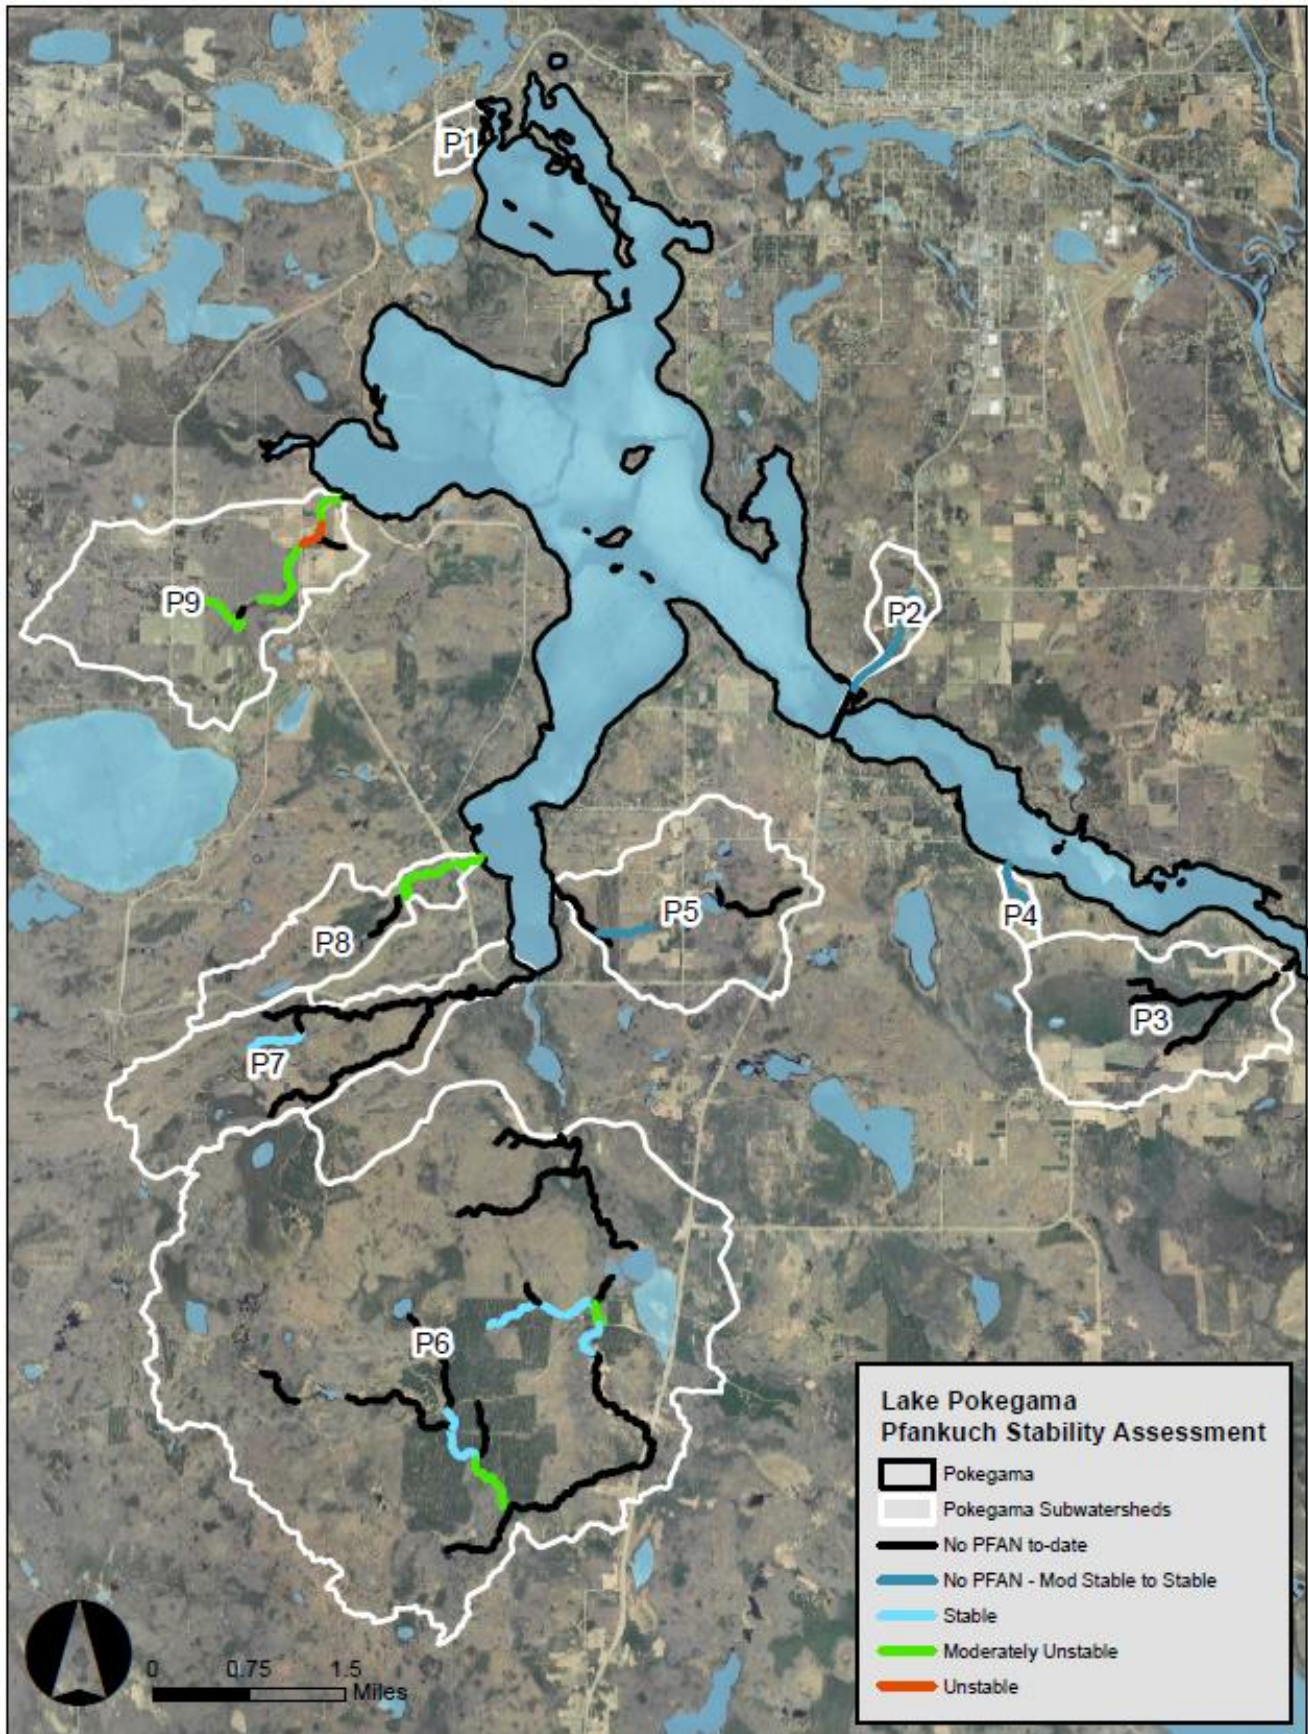
Figure 10. Pfankuch stream stability condition results for reaches within the Lake Pokegama watershed.

A stream stability assessment was performed for reaches requiring a field assessment was identified in the desktop analysis (Table 7; Figure 10). The assessment summed scores relative to upper and lower banks and the streambed to provide indication of overall channel stability. Four reaches were not assessed for stability given access limitations (P3 and 4), the channel was non-contributing/un-defined (P5) or was a roadway ditch (P2). Possible ratings included unstable, moderately unstable or stable. One reach was considered unstable, five were moderately unstable and nine were stable. Unvisited reaches are expected to score predominantly as stable.

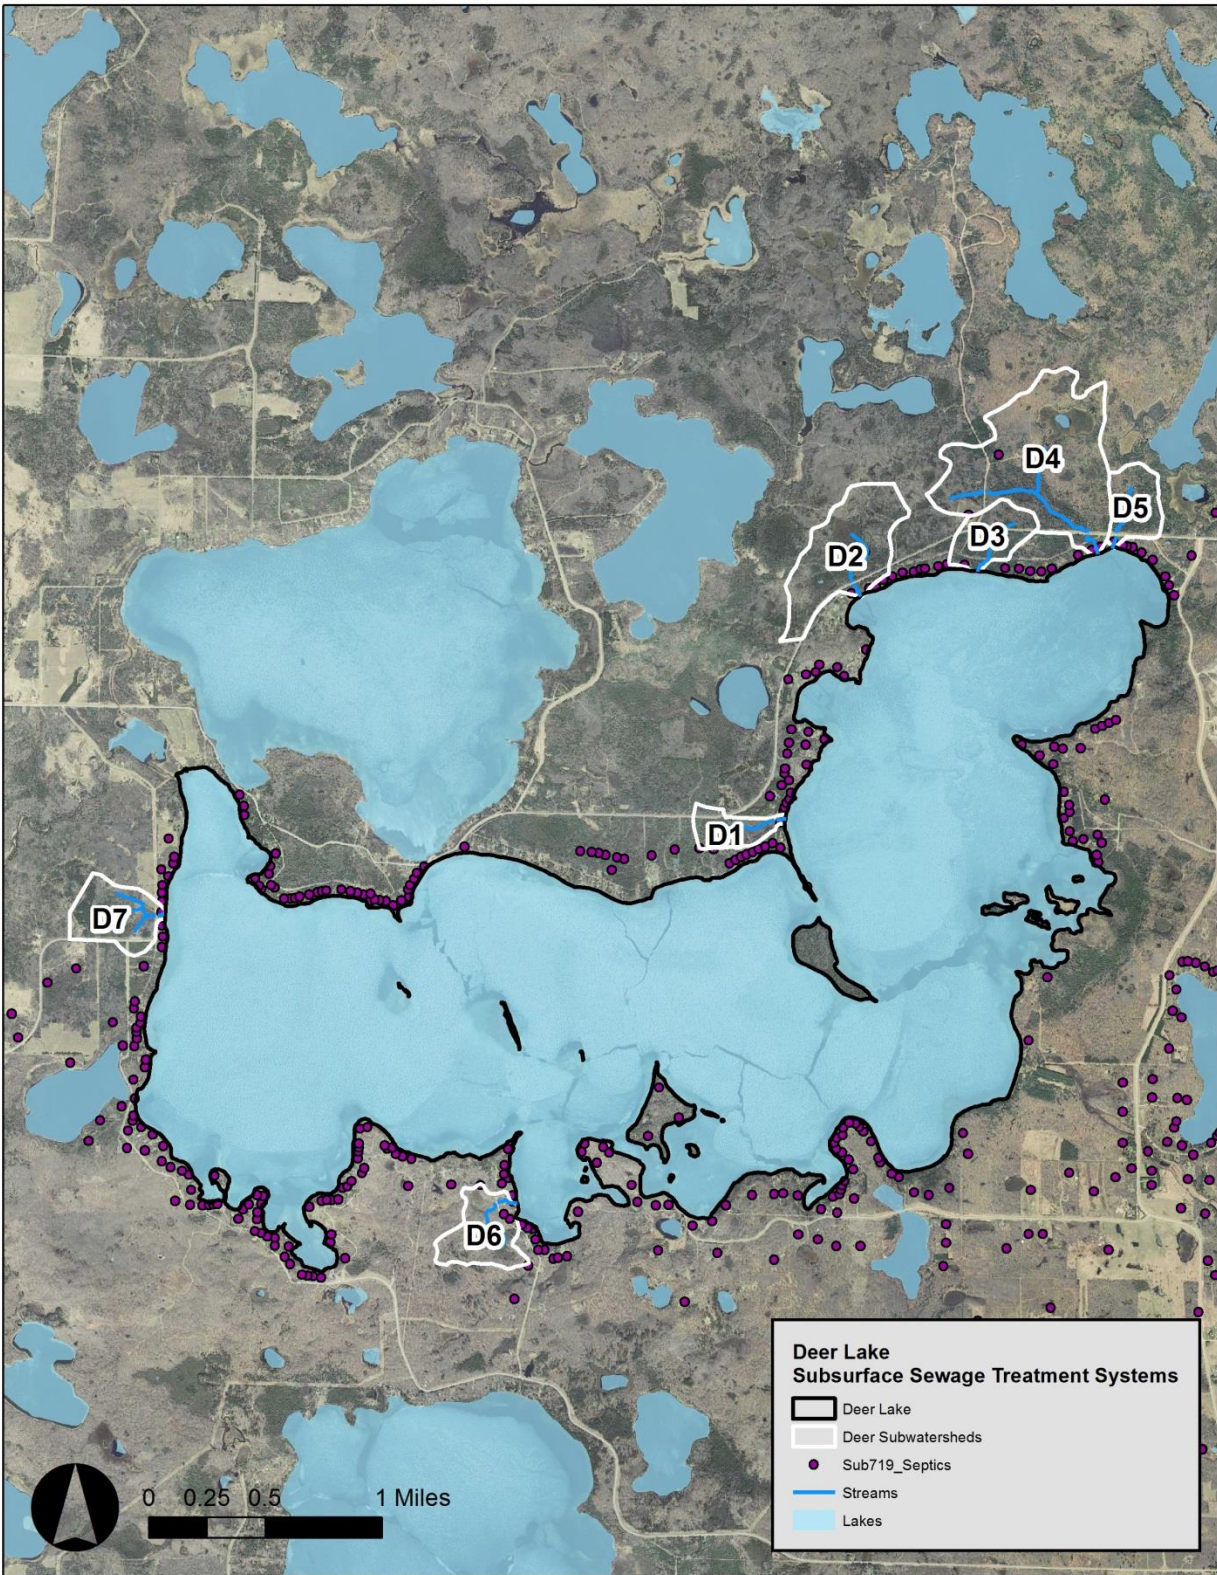
Figure 14. Deer Lake Subsurface Sewage Treatment Systems

Deer Lake is similar to Pokegama in that many of its subsurface sewage treatment systems are located near the shoreline in hilly topography (Figure 14). Subsurface sewage treatment systems (SSTS) were mapped for the Pokegama watershed to investigate relative proximity to stream channels. No attempt was made to validate the County's spatial data accuracy for the exact position within the landscape. Very few SSTS appear close to the stream channels associated with the subwatersheds of concern visited in this study and are therefore not at risk to stream encroachment. As mentioned for Pokegama, the second risk associated with SSTS proximity to channels is related to ground water conveyance of SSTS infiltrate and associate nutrients. It was beyond the scope of this study to evaluate this risk thoroughly, though it is recommended that an evaluation of SSTS compliance to modern State Standards is recommended.

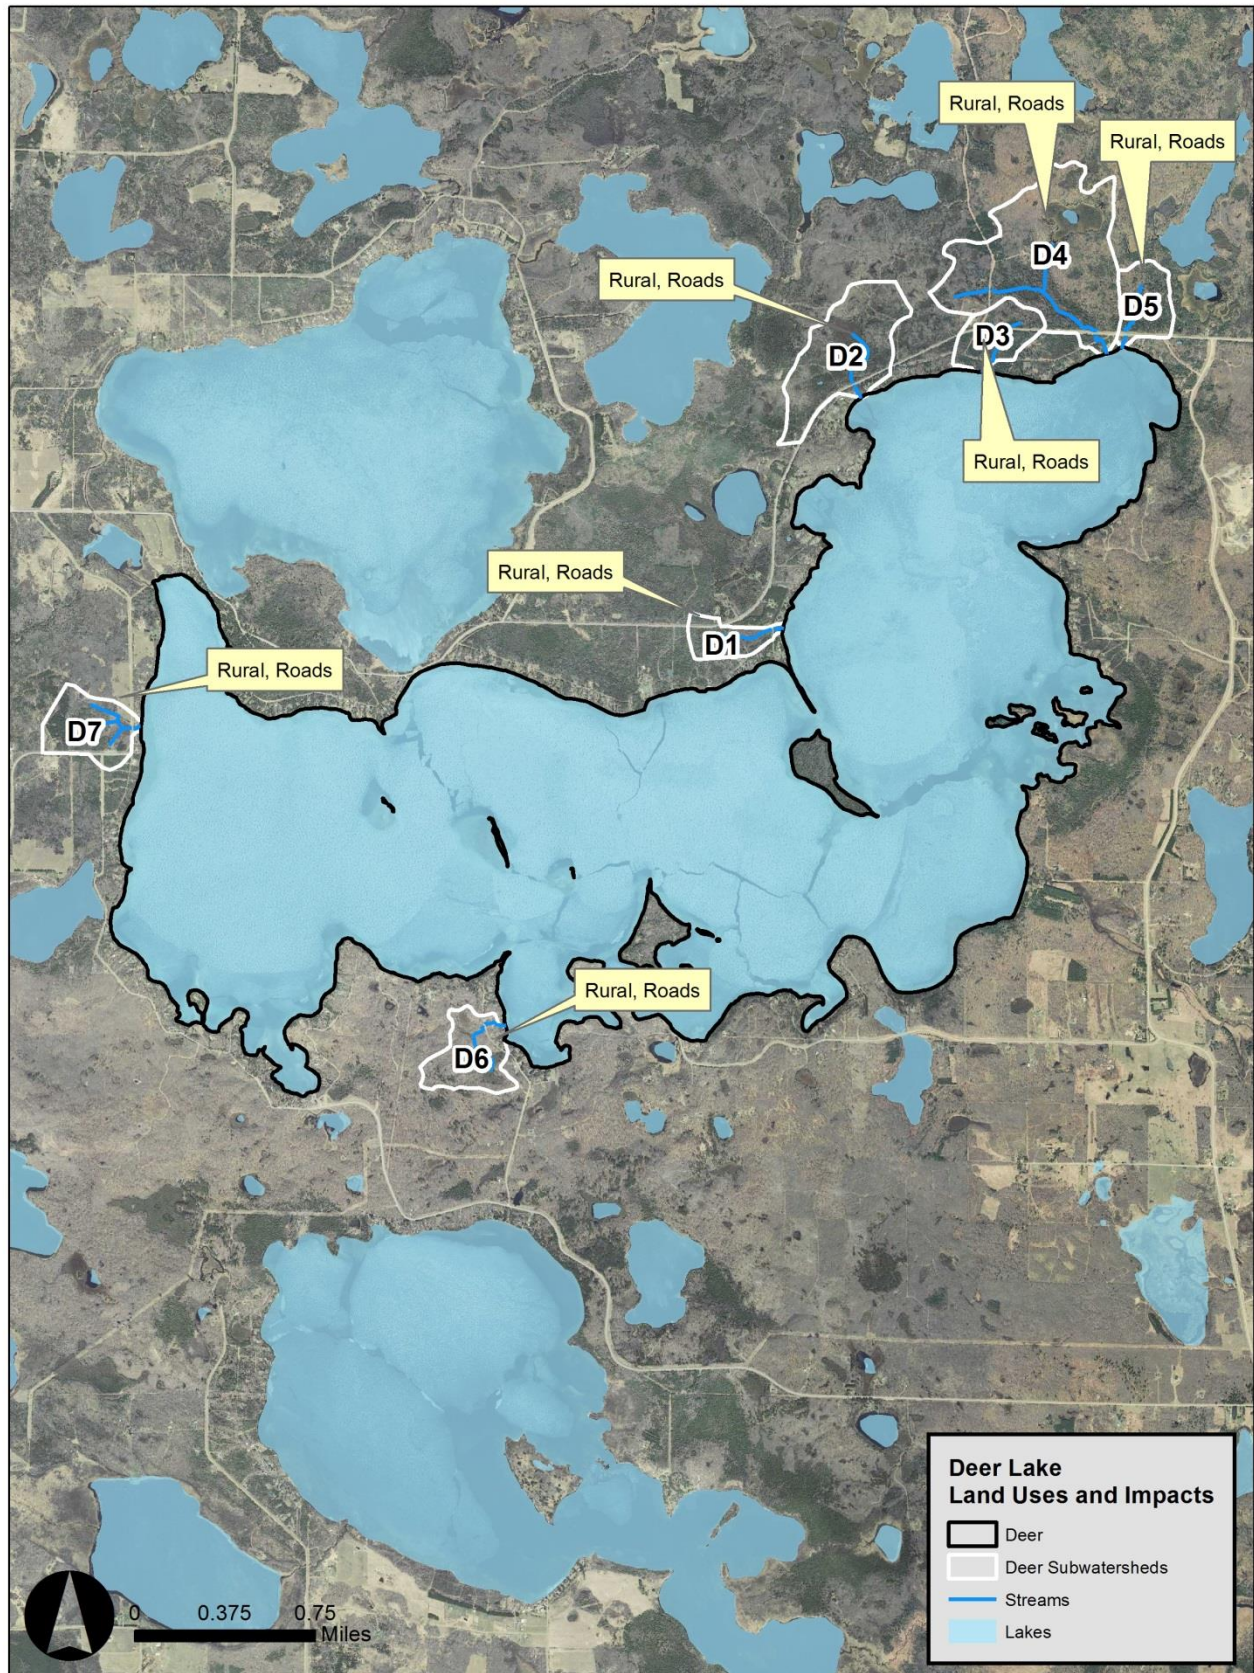
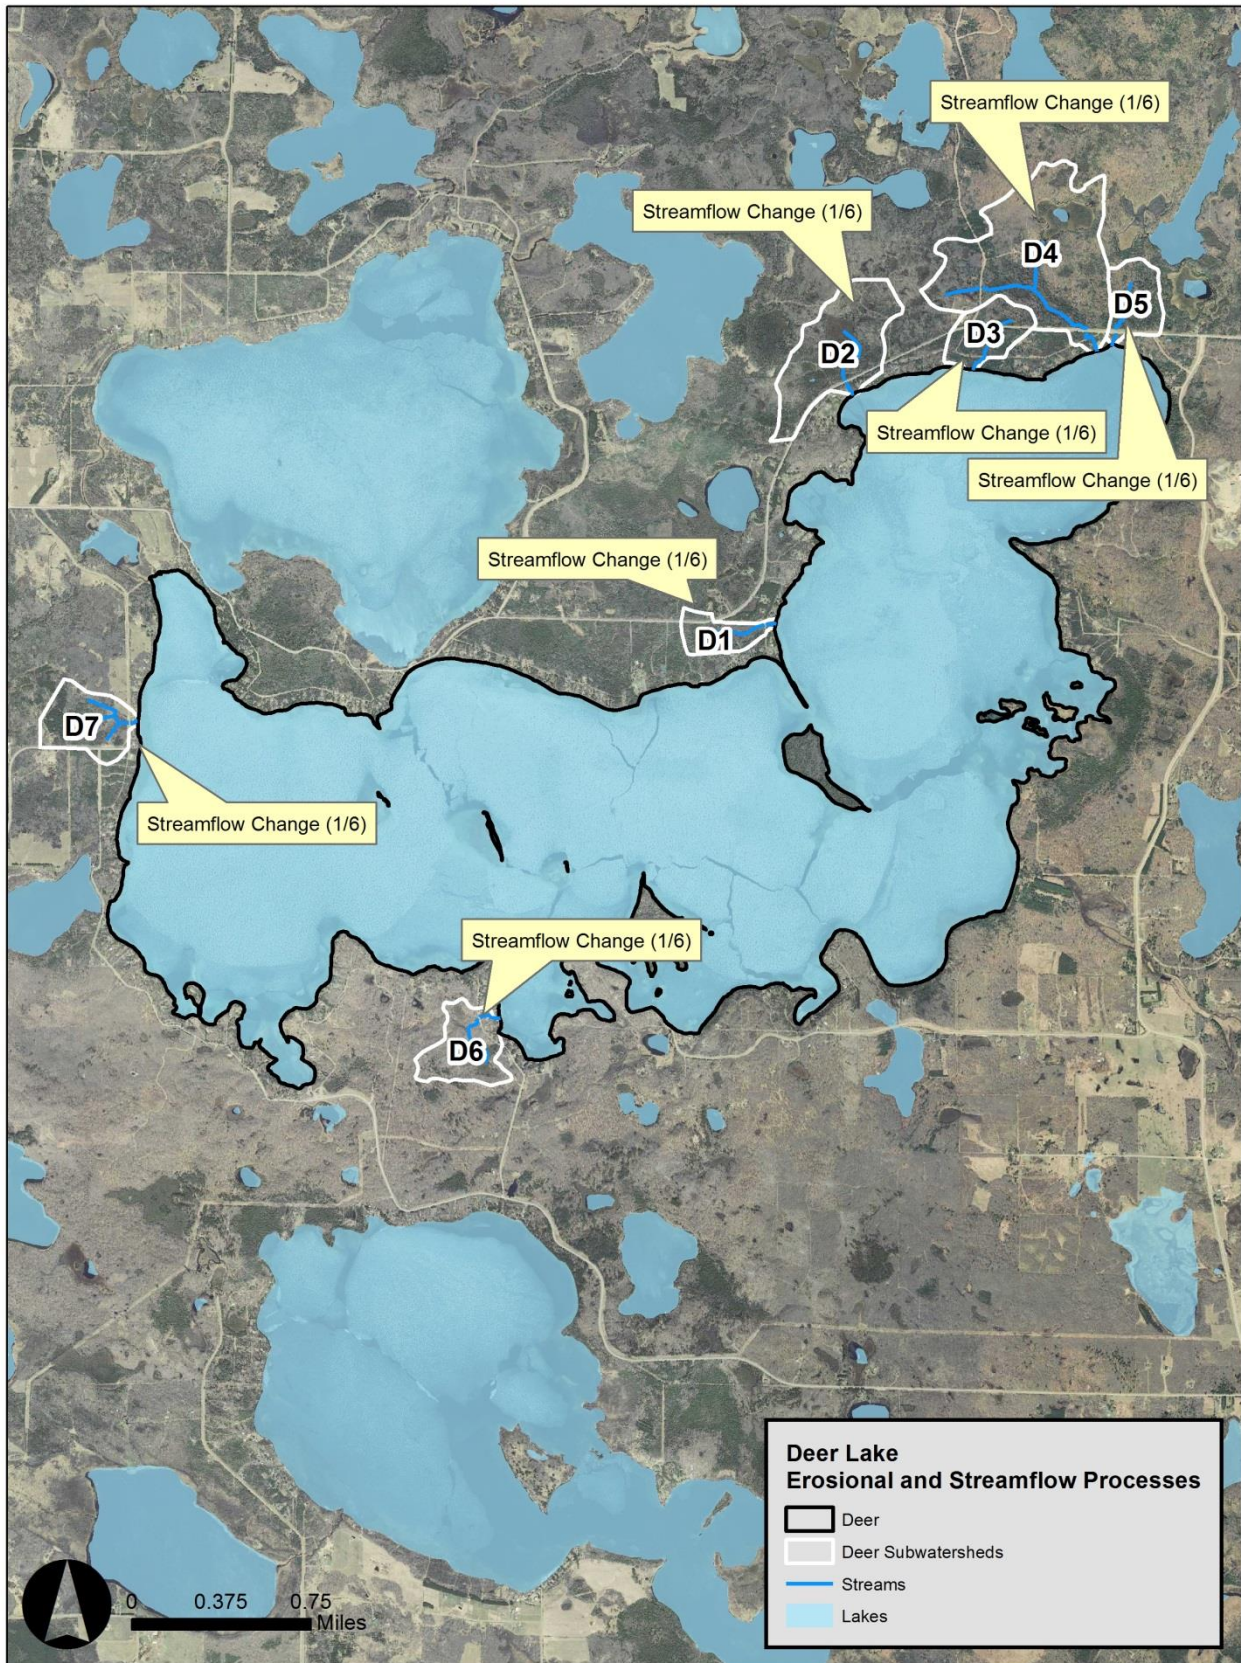
Deer Lake's subwatershed is comprised of relatively in-tact forest and rural development with no current logging or obvious clearing that may adversely influence water quality within streams and the Lake (Figure 16; Figure 17).
